Manhole Inspection Summary

Manhole # **S43GG_036MH**

Location Address: **1758 PRESTON ST**

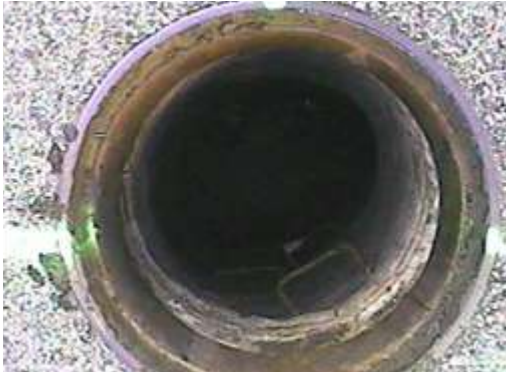
Defect 1

Offset: **2** (in.)

FRAME OFFSET

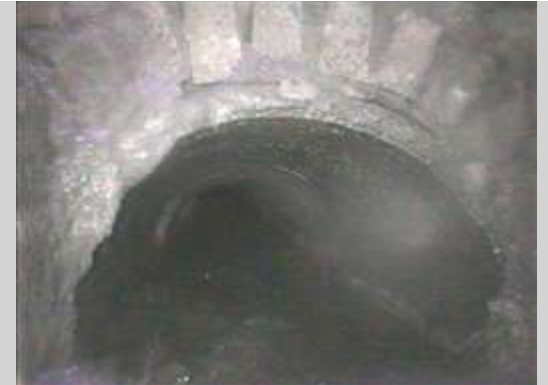
12 O'Clock Outflow

21 in. Circular Gravity Sewer
Pipe Out @ 12 O'Clock

Pipe Height: **14.4** (in.) Rod and Bar
Pipe Material: **Clay** ☐ Pipe Lined
Invert Depth: **10.59** (ft.) Flow Characteristics: **Fast**
Deposits: ☐ None ☐ Mud ☐ Sludge ☒ **Debris** ☐ Grease
Silt Depth: **3** (in.) Deposits Extent: **Medium**
Infiltration: **None** Pipe Seal Cond: **Sound**

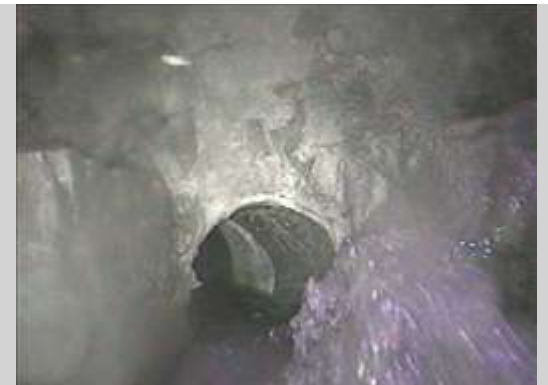
3 O'Clock Inflow

8 in. Circular Gravity Sewer
Pipe In @ 3 O'Clock

Pipe Height: **4.8** (in.) Rod and Bar
Pipe Material: **Clay** ☐ Pipe Lined
Invert Depth: **10.12** (ft.) Flow Characteristics: **Turbulent**
Deposits: ☒ None ☐ Mud ☐ Sludge ☐ **Debris** ☐ Grease
Silt Depth: (in.) Deposits Extent:
Infiltration: **None** Pipe Seal Cond: **Sound**

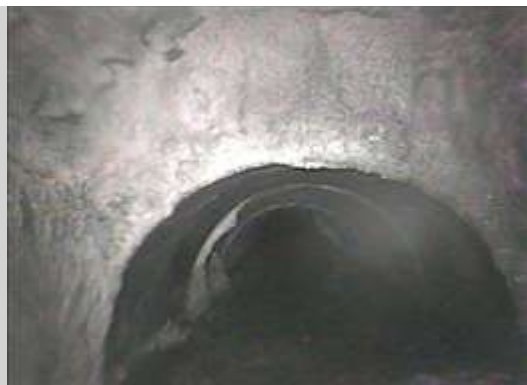
9 O'Clock Inflow

21 in. Circular Gravity Sewer
Pipe In @ 9 O'Clock

Deposits: ☐ None ☐ Mud ☐ Sludge ☒ **Debris** ☐ Grease

Silt Depth: **3** (in.) Deposits Extent: **Medium**
